Contaminated Sites

Environmental Engineering

Active cap stops LNAPL sheen on canal

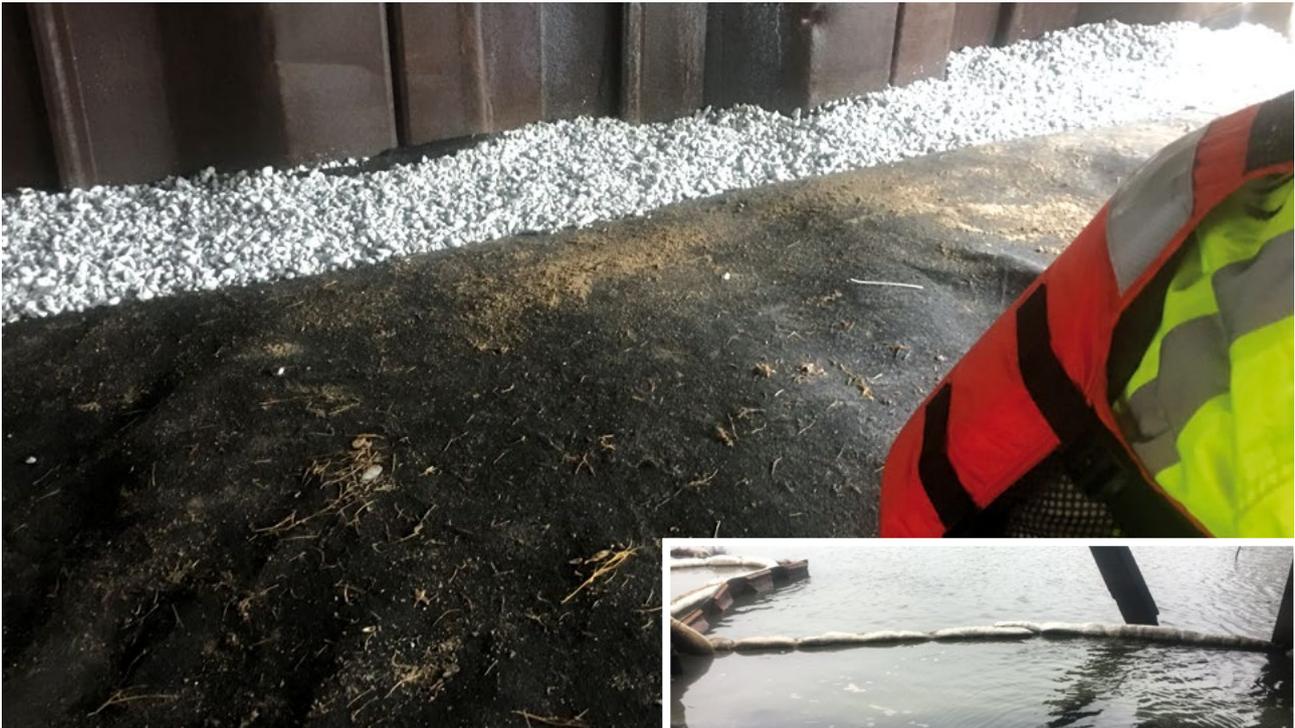
Tektoseal Active installed with anchor trench at sheet pile wall

Work was done in winter when a frostline existed near the surface which temporarily stopped the seep. There was existing armor stone and debris along the shoreline which was first removed to the extent possible. Where debris and other protrusions could be feasibly removed, a sand levelling layer was placed. The Tektoseal Active panels were deployed perpendicular to the shoreline and anchored in a trench at top of the slope. Adjacent panels were overlapped a minimum of 1 foot. Panels were cut, as needed, to fit around pipelines and bridge structures. Since the canal

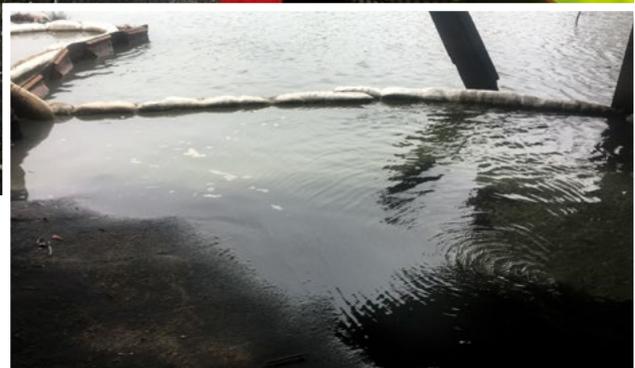
Petroleum sheen prior to installation

A major oil company operated a tank farm in the Midwest adjacent to a canal. A leak developed resulting in a petroleum plume at the air-water interface of the groundwater. The plume migrated toward the canal and daylighted on the bank resulting in sheen on the waterway. Arcadis US was contracted to design a remediation plan. A boom was deployed to contain the sheen. Assessment and design began to remediate the main source zone of the LNAPL plume. LNAPL was still expected to continue to migrate into the canal until the full remedy was complete.

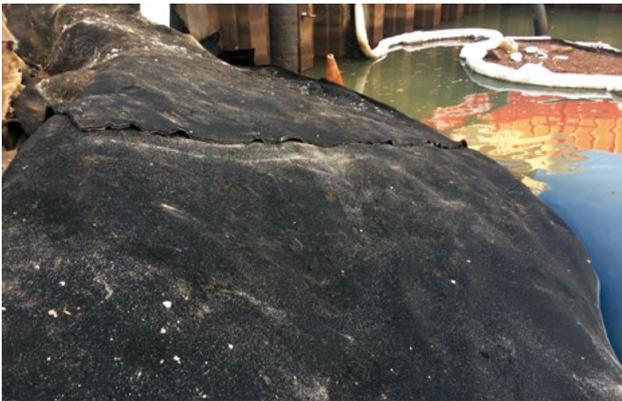
Tektoseal Active installation prior to cover placement

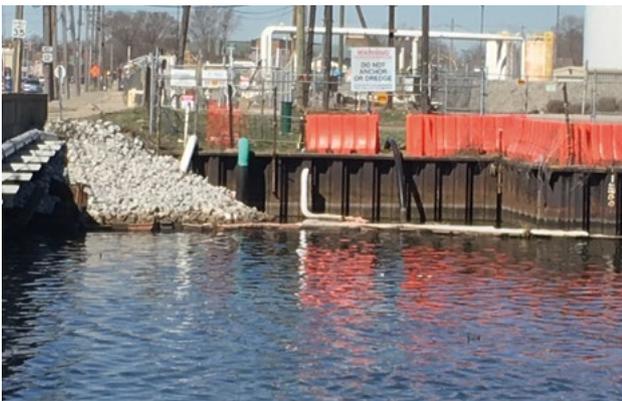
15 months after installation – view across canal

A visit to the site was conducted 15 months after the construction of the project. The boom has been kept in place as a precaution, but there is no petroleum sheen observed in the waterway.

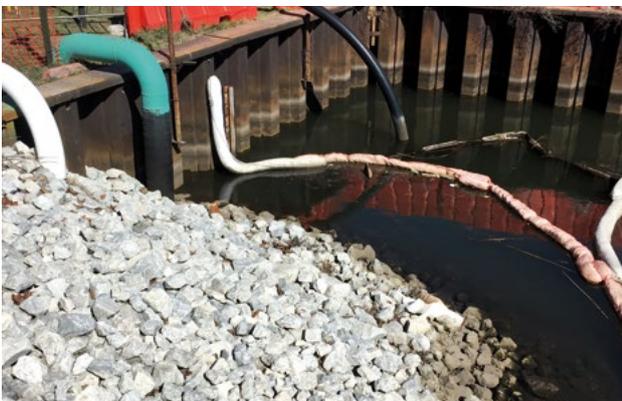
15 months after installation – no sheen
