Reinforced steep vegetated slope 60 m height for landslide stabilization in Lona-Lases (Trento-Italy)

Keywords: reinforced steep slopes, geogrids, landslide stabilization

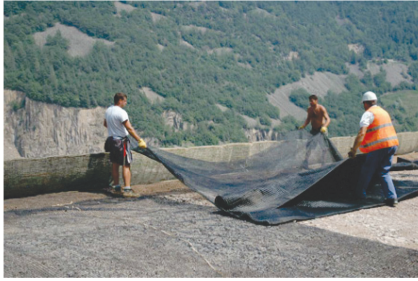
Figure 5. Installation of primary reinforcing geogrid.

Reinforcement geogrids have been installed using wrap-around technique (Fig. 5) and heavy compaction every 30 cm thick layer of filling has been applied. Filling compressibility modules M_v , according to Swiss Standard (SNV 671307), determined with loading plate test measured under tensions between 0.15 and 0.25 N/mm² had to be always higher than 40 N/mm², while density higher than 90% of maximum Modified Proctor density according to AASHTO.

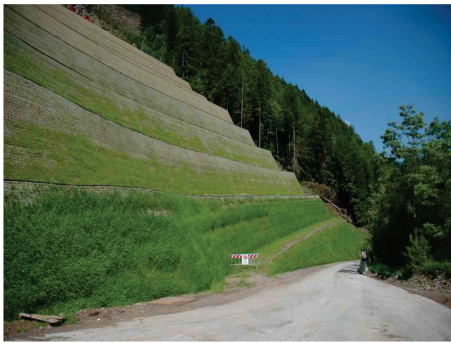
Figure 6. View of slope with starting vegetation during summer 2005.

High thickness hydroseeding was sprayed on facing in progressive steps following the building of reinforced slope in height, to minimize environmental impact. An automatic irrigation plant with sprinkles installed on crest of face helped starting vegetation to grow during hot and dry summer period (Fig. 6).

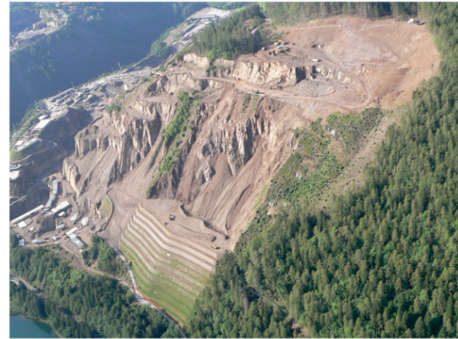
Figure 7. Aerophotogram of the reinforced steep slope completed.

The reinforced steep slope has been completed in September 2005 (Fig. 7) and the automatic monitoring system installed is constantly measuring the behaviour of the structure and the versant.
